# Preventing Infection in MRI

*-Best Practices: Infection Control in and around MRI Suites-*

By

**Peter Rothschild, MD**

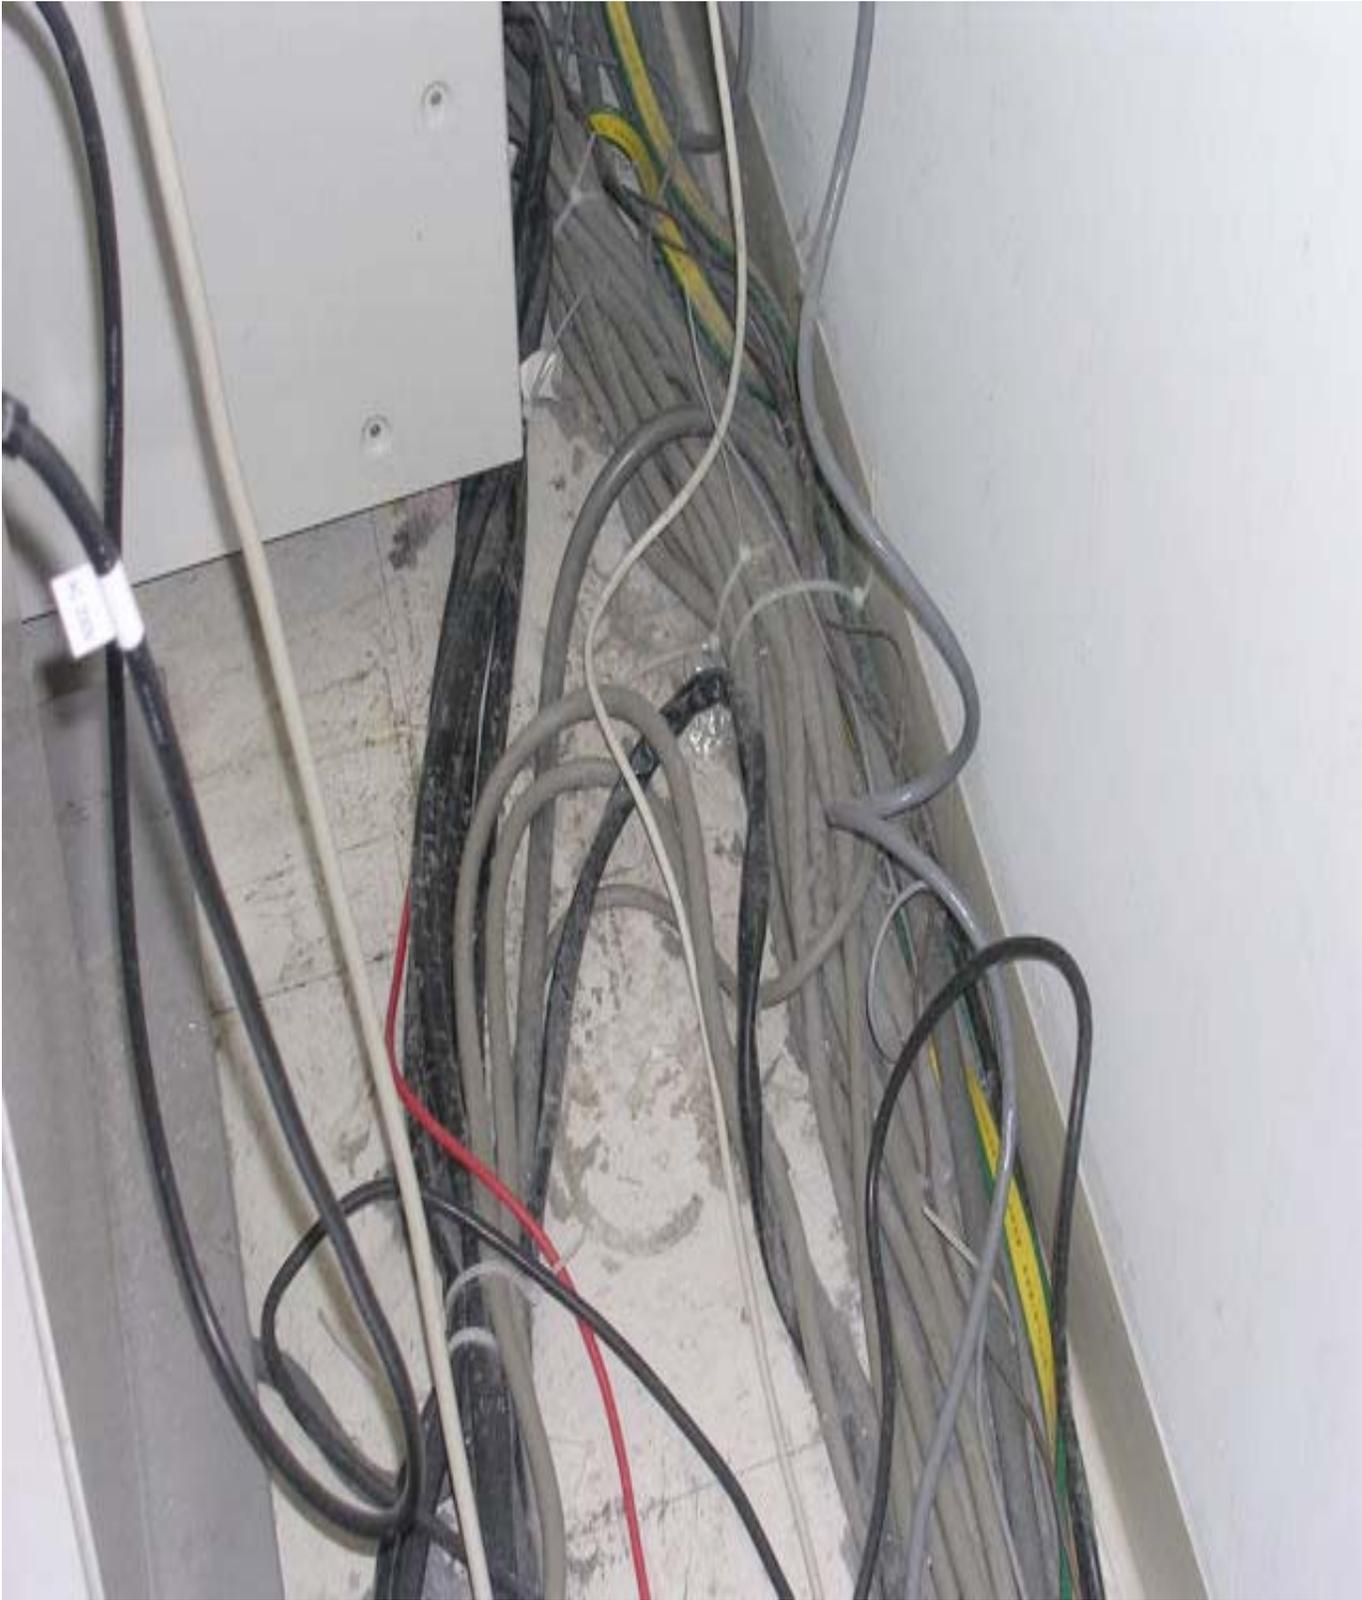
Cables in the MRI Room

The pictures below are just a few examples of just how unbelievably dirty these MRI suites can be.

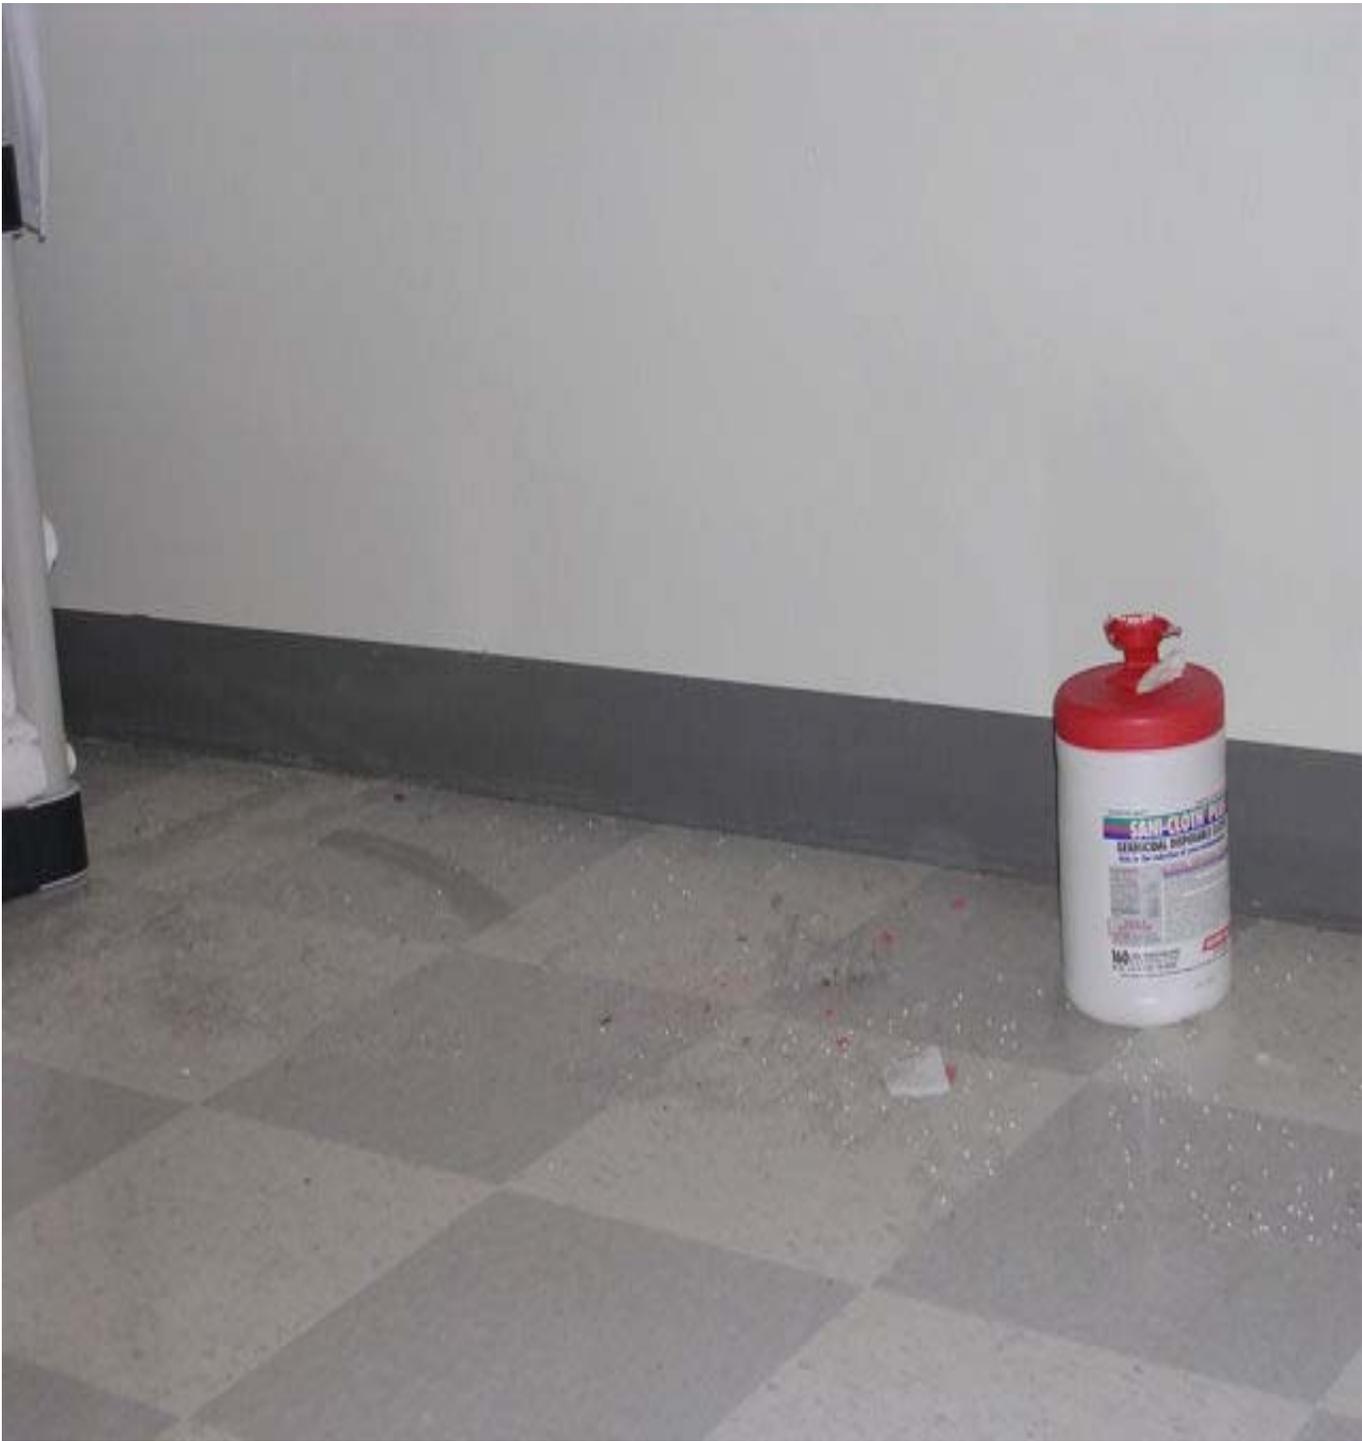
MRI Floor – Note that only the front half has been cleaned

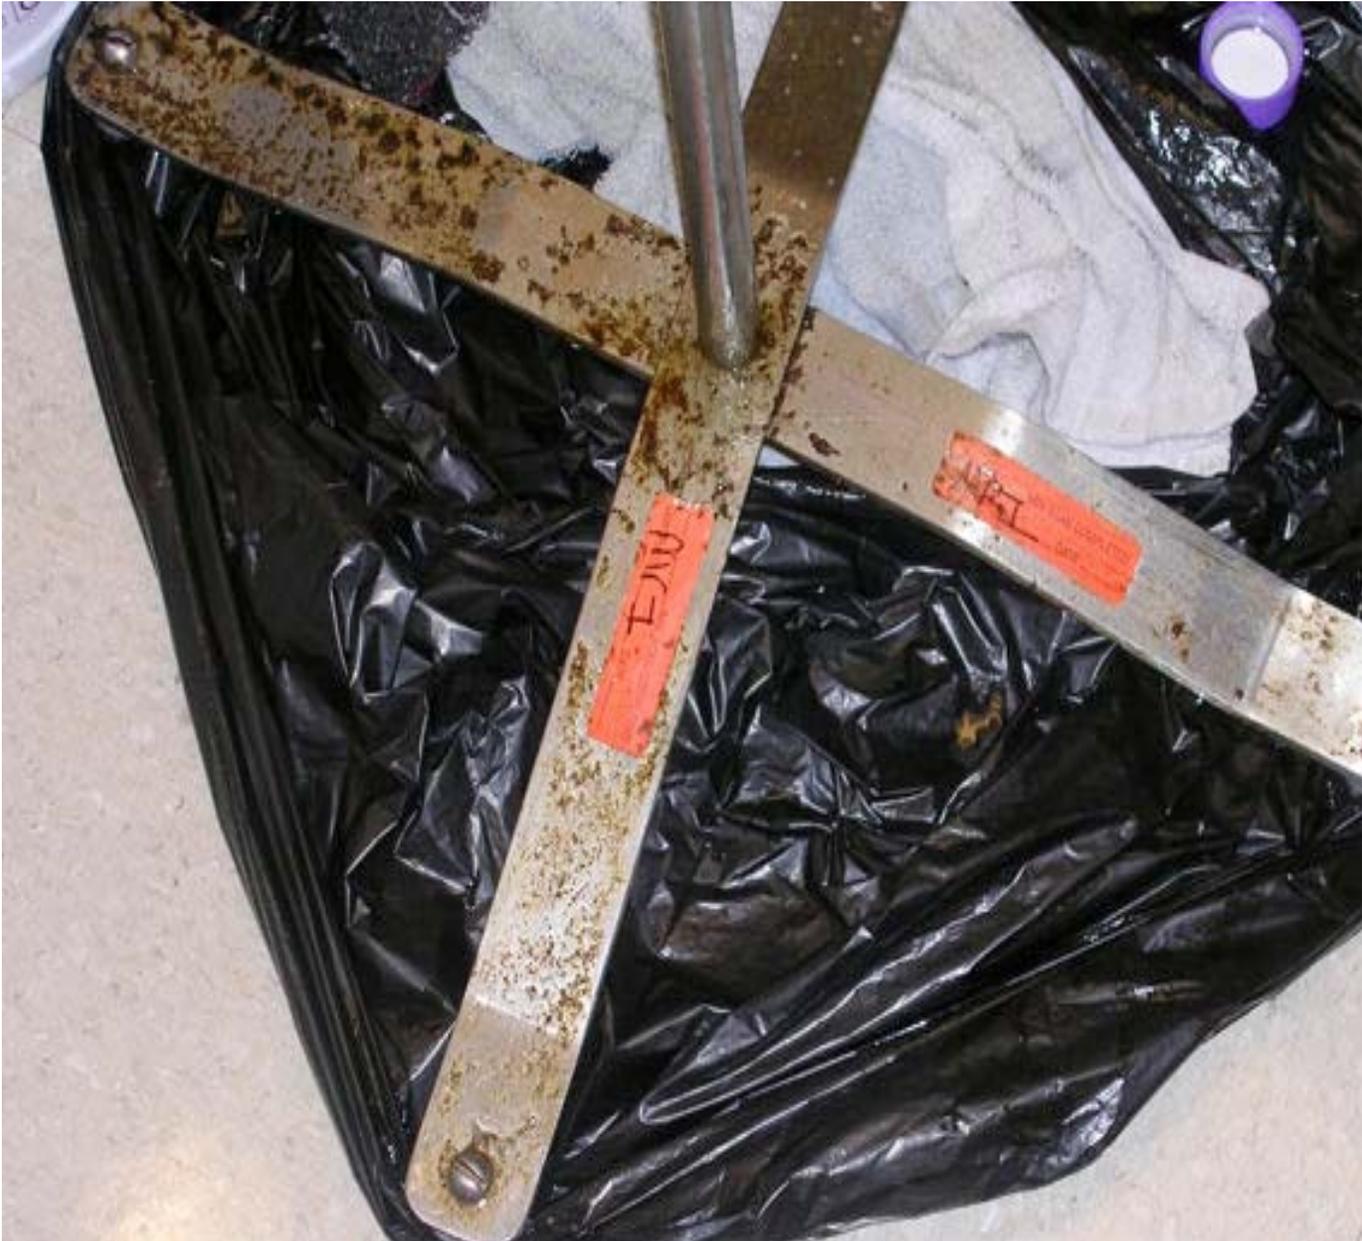
MRI-Compatible Aluminum IV Pole

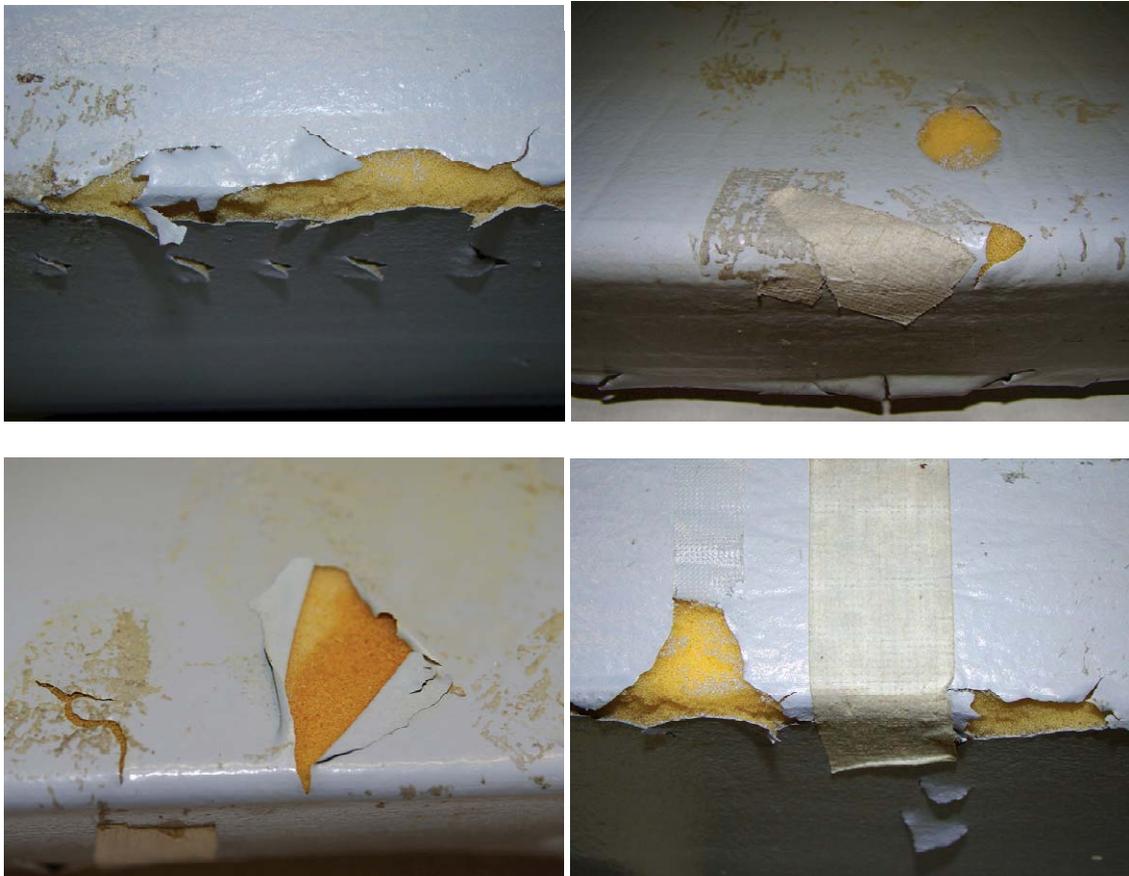
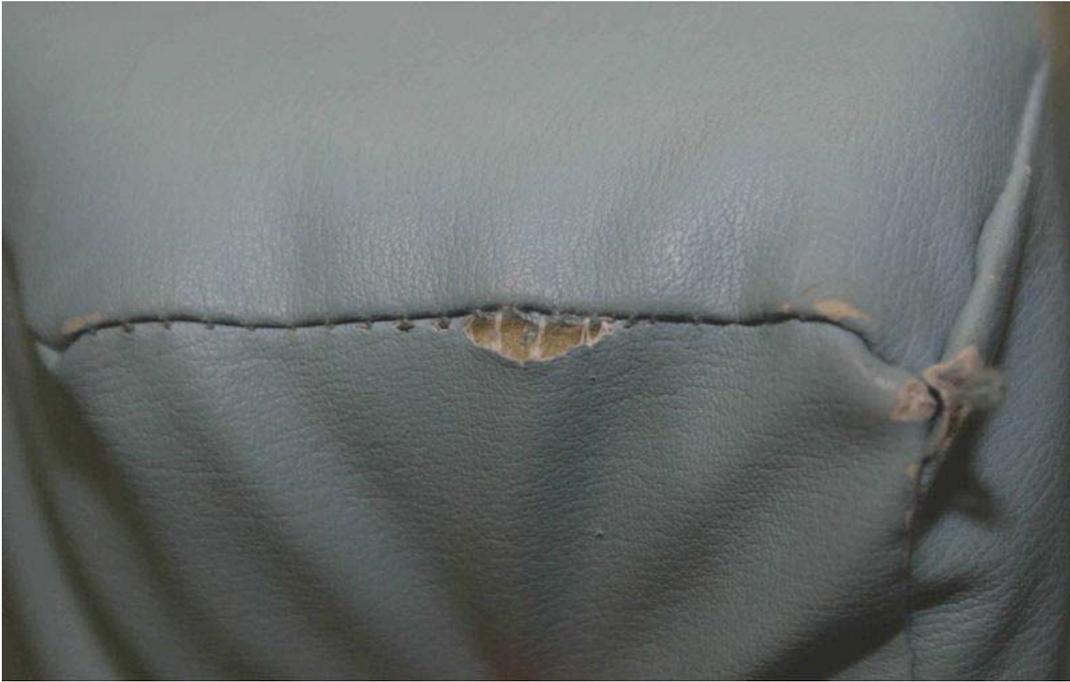
Torn and Frayed Table Pad

In the late 1980’s and early 1990’s when many of the pads systems in use today were developed, they were not designed to take the wear-and-tear of five to ten thousand patients a year for so many years. The fabric covers were coated with some type of plastic to make it water proof. However this plastic wears off especially with cleaning solutions as well as with use. As a result, pad coverings have worn out exposing the foam core or have lost their ability to prevent penetration of bacteria and fluids into the central core, where it is not possible to be cleaned.

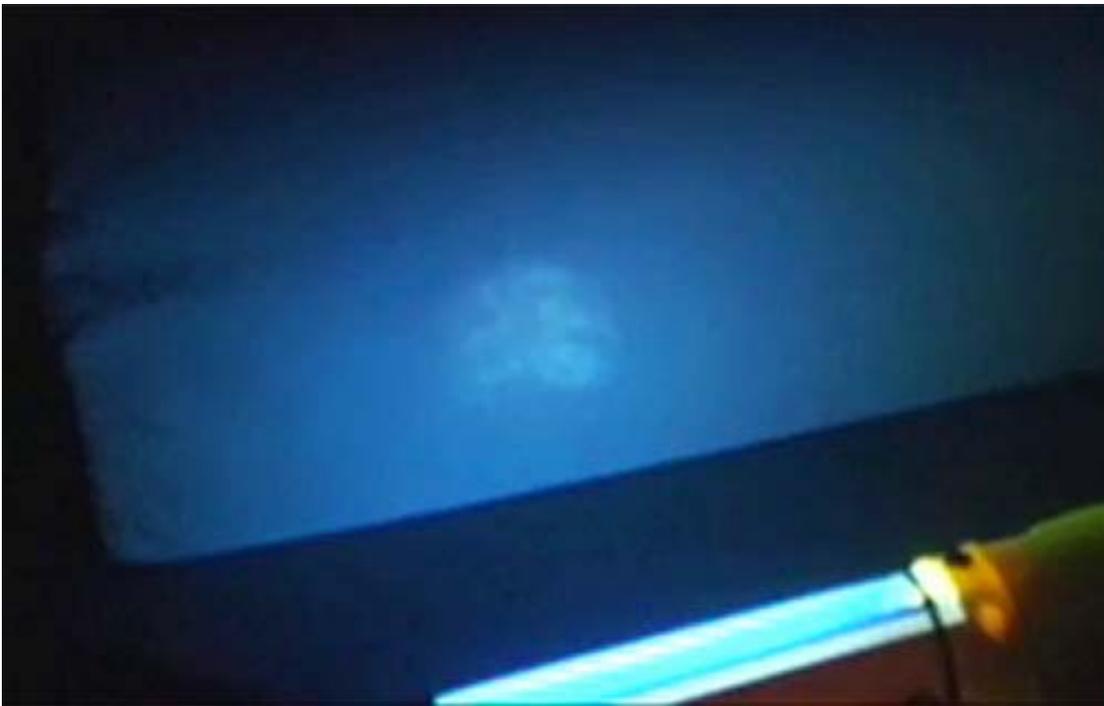
It is also important that all pads be periodically tested using a black light to detect biologic contamination. A black light provides light in the ultraviolet wavelengths that is especially sensitive in detecting biological material such as blood, fingerprints, body fluids, etc. Biological material remaining on the pads will light up under black light exposure. This is an excellent way to confirm that the cleaning procedures are adequate. If biological material remains after proper cleaning it may indicate the covering material has been frayed or breached, thus allowing fluids to seep into the fabric itself and possibly penetrate to the underlying foam. Experiments performed by Ryan Whitney (a medical student who experimented with MRSA and MRI pads) (personal communication) have shown that MRSA could even go through frayed fabric covers without a tear and get into the central core where it is not possible to disinfect. This also demonstrates the necessity for pads and positioners to contain permanent antimicrobial agents in the covers and foam cores. More studies are needed to more thoroughly understand the depth of this problem and exactly how many pads in use today are contaminated.
