Preventing Infection in MRI

-Best Practices: Infection Control in and around MRI Suites-

Peter Rothschild, MD

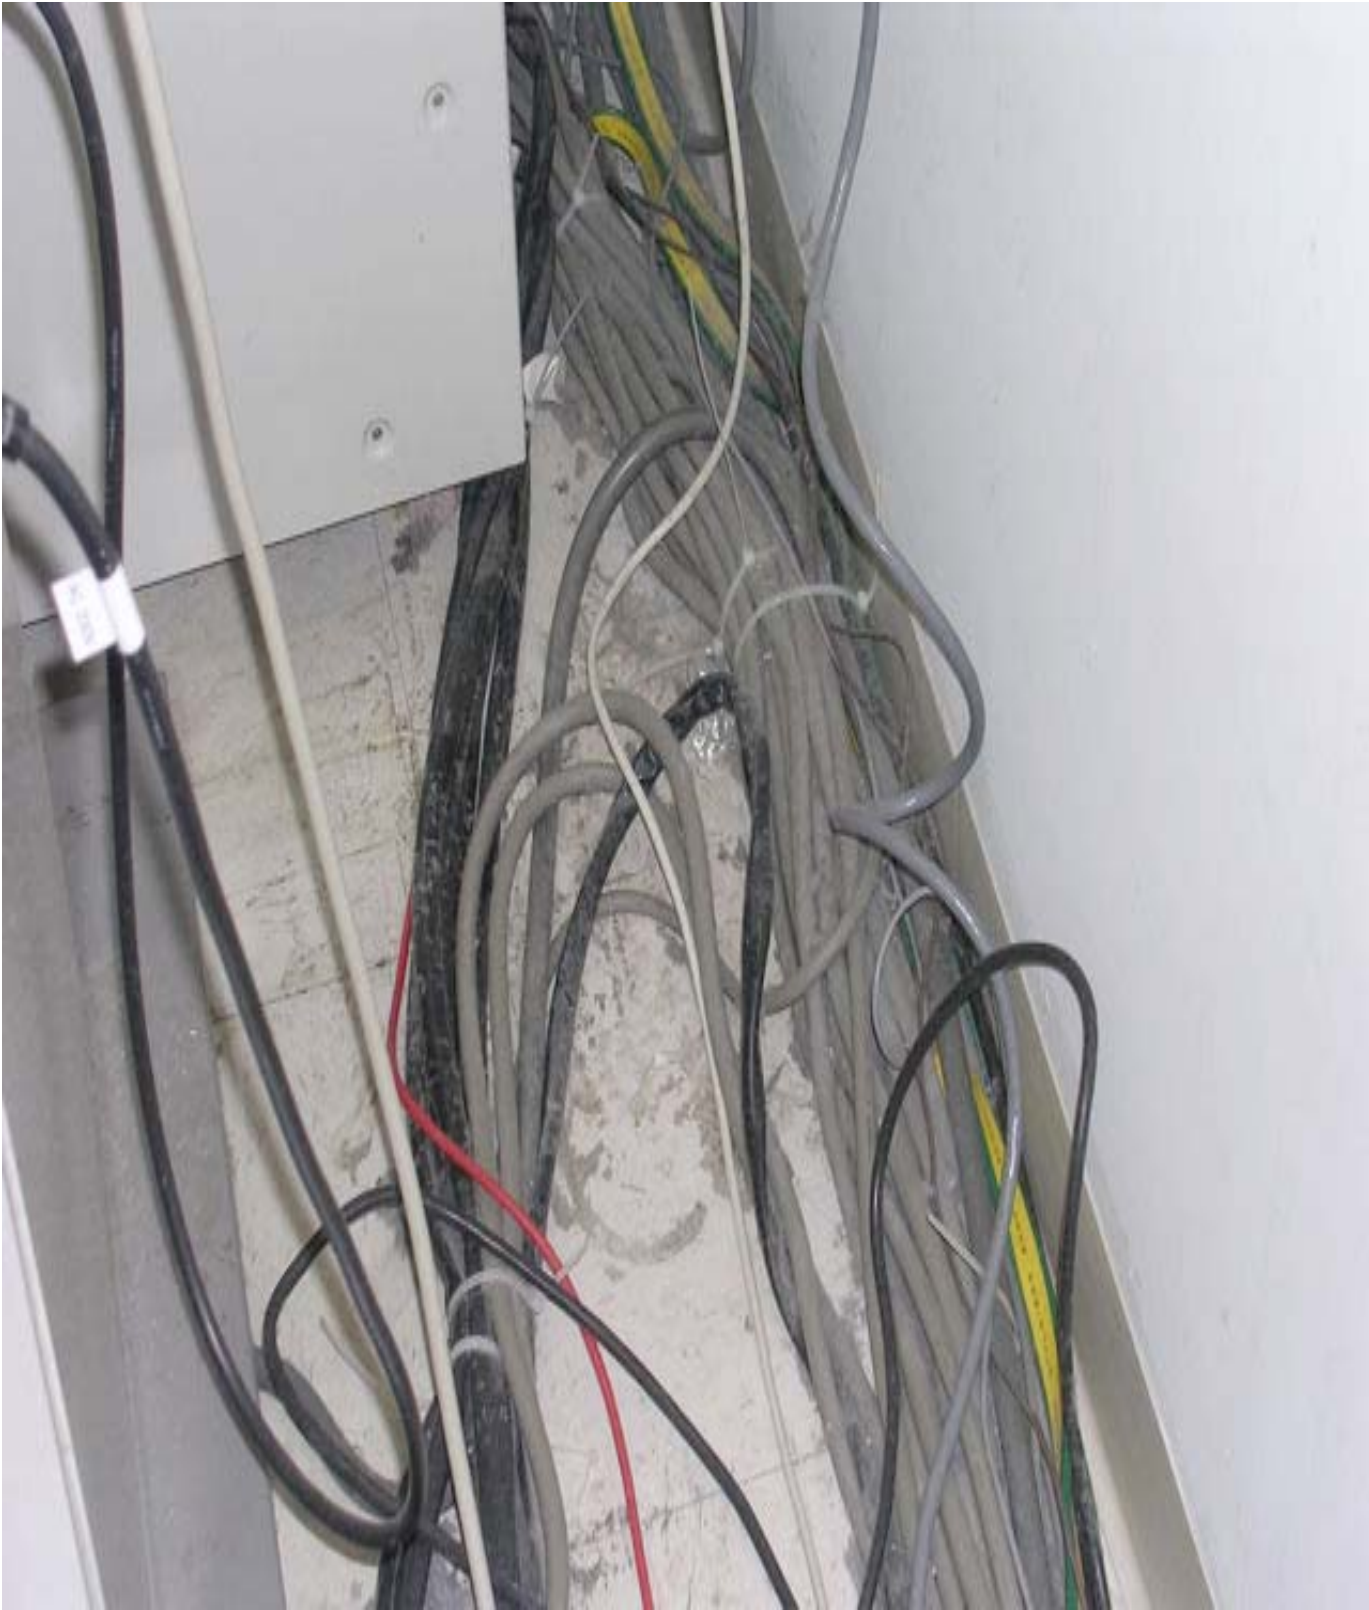
Cables in the MRI Room

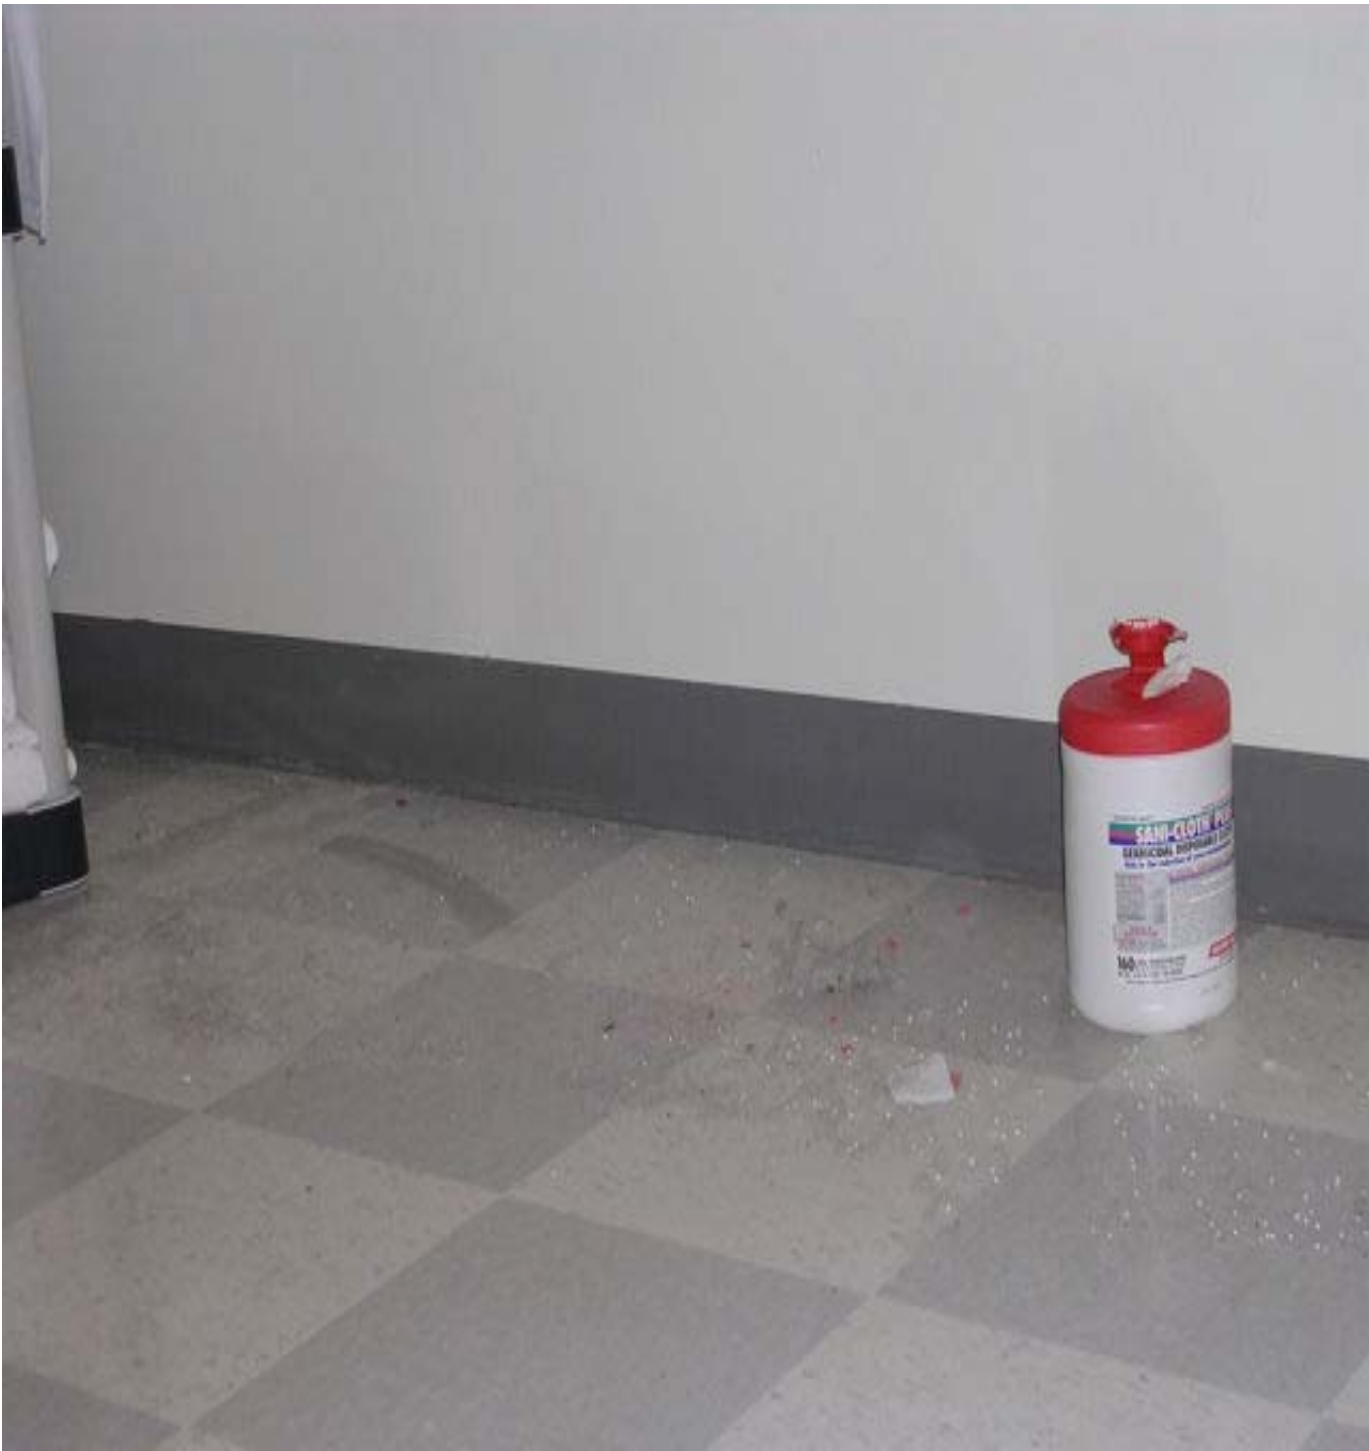
MRI Floor – Note that only the front half has been cleaned

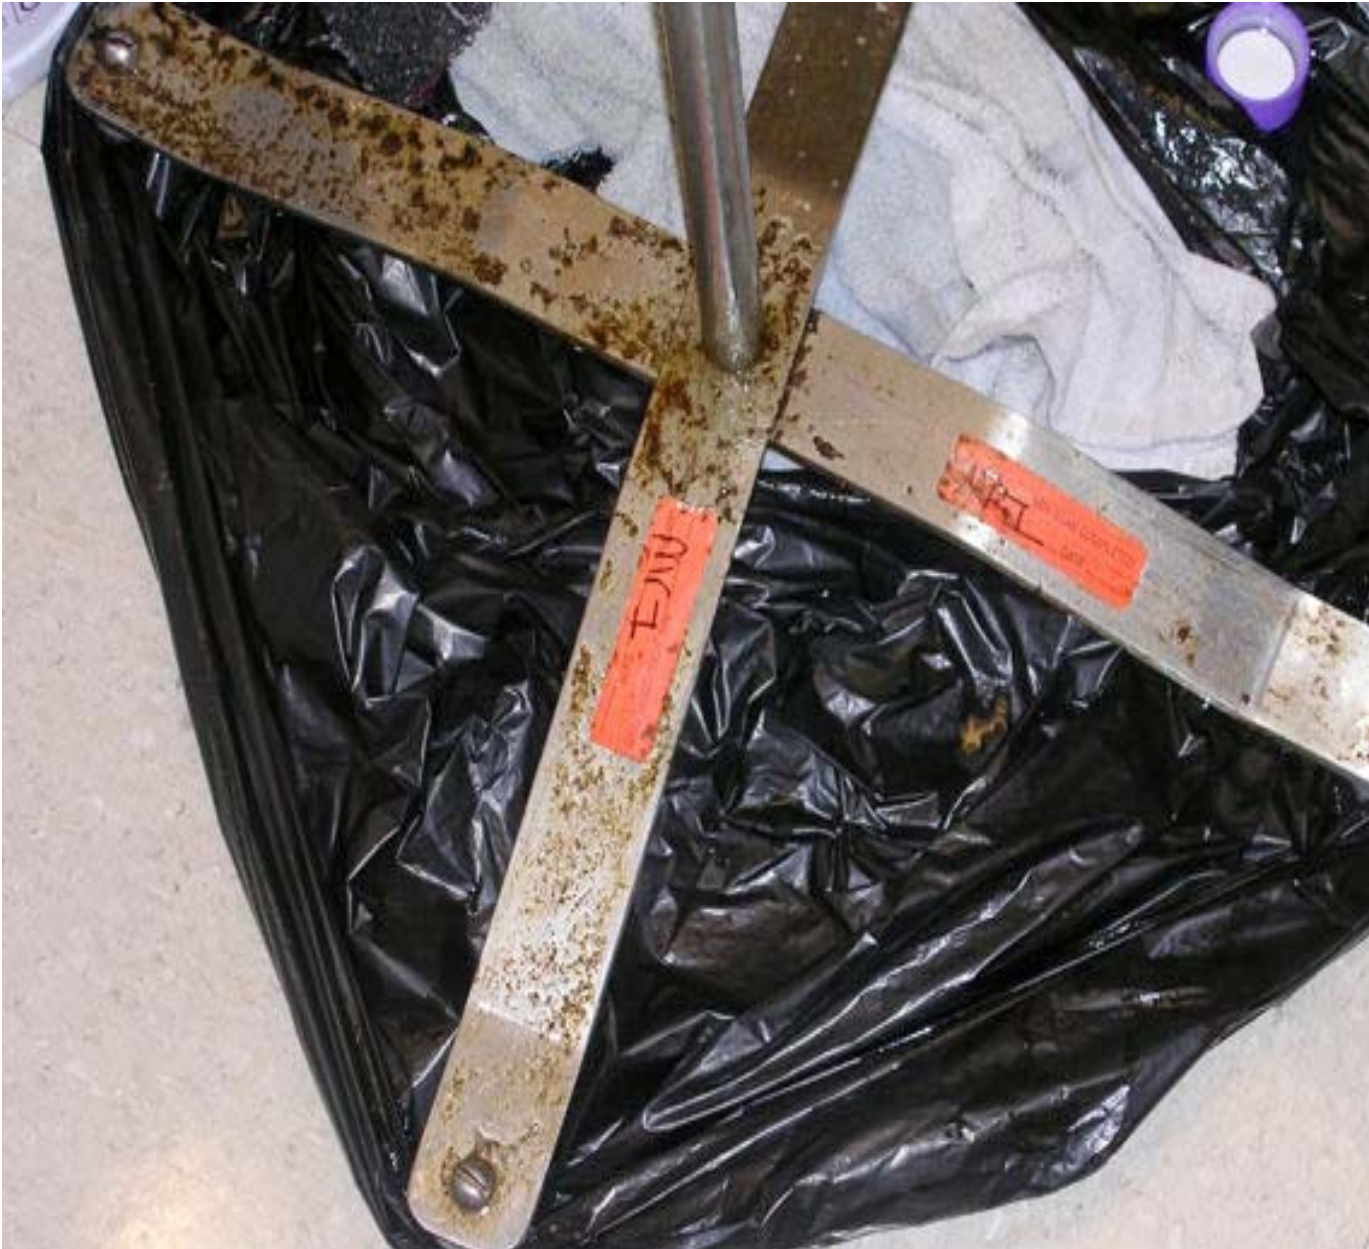
MRI-Compatible Aluminum IV Pole

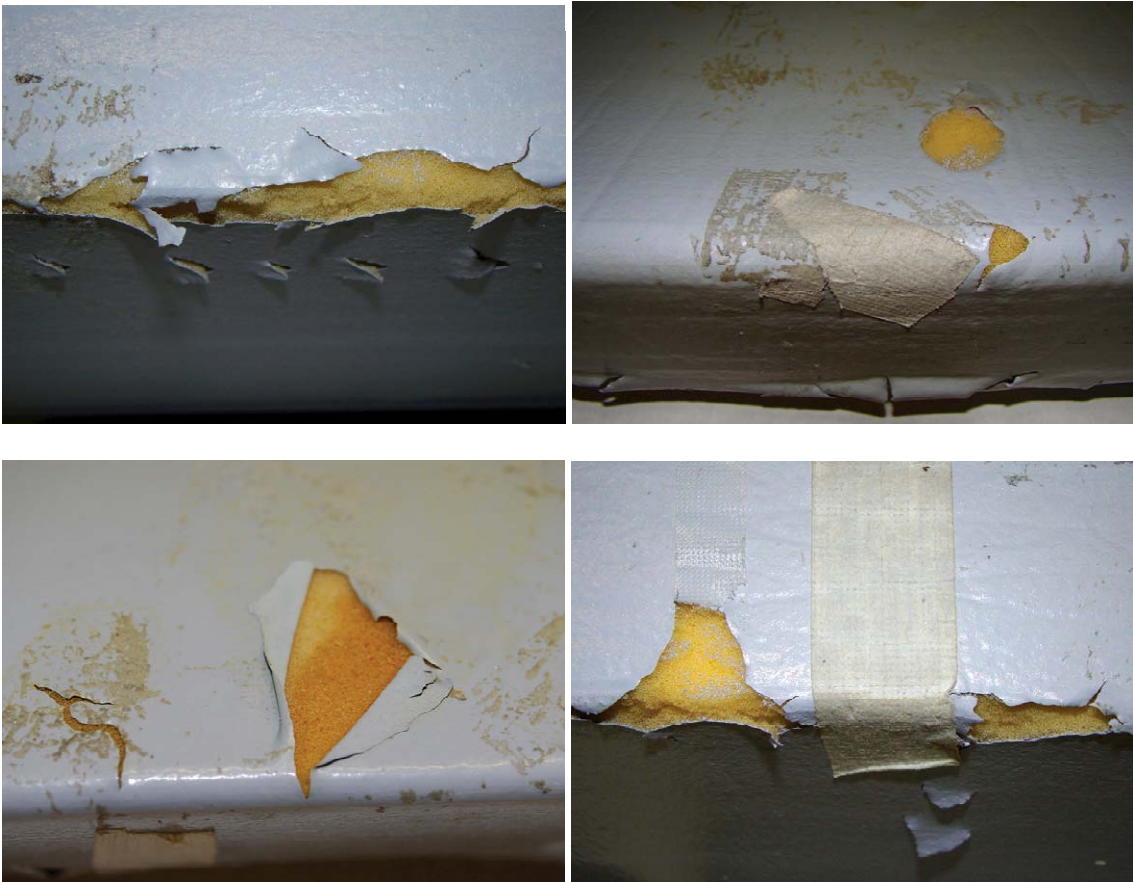
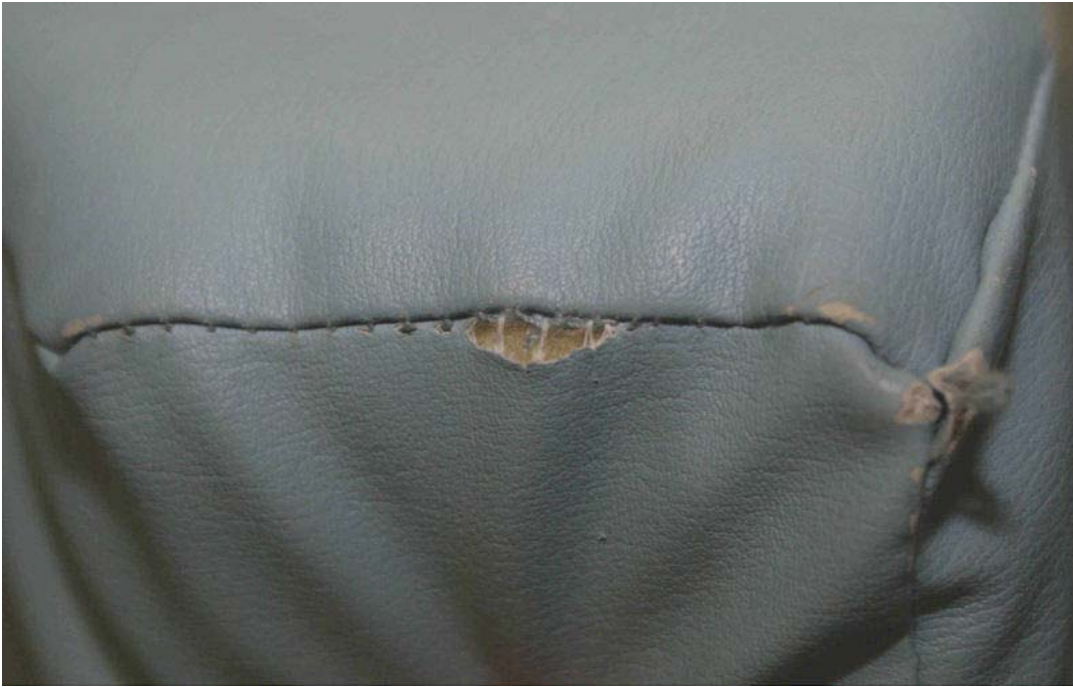
Torn and Frayed Table Pad

In the late 1980’s and early 1990’s when many of the pads systems in use today were developed, they were not designed to take the wear-and-tear of five to ten thousand patients a year for so many years. The fabric covers were coated with some type of plastic to make it water proof. However this plastic wears off especially with cleaning solutions as well as with use. As a result, pad coverings have worn out exposing the foam core or have lost their ability to prevent penetration of bacteria and fluids into the central core, where it is not possible to be cleaned.

This is clearly another reason why all pads must be inspected with a magnifying glass, and if any holes or loss of integrity of the covering material in any way is detected, the pads *must be replaced*.

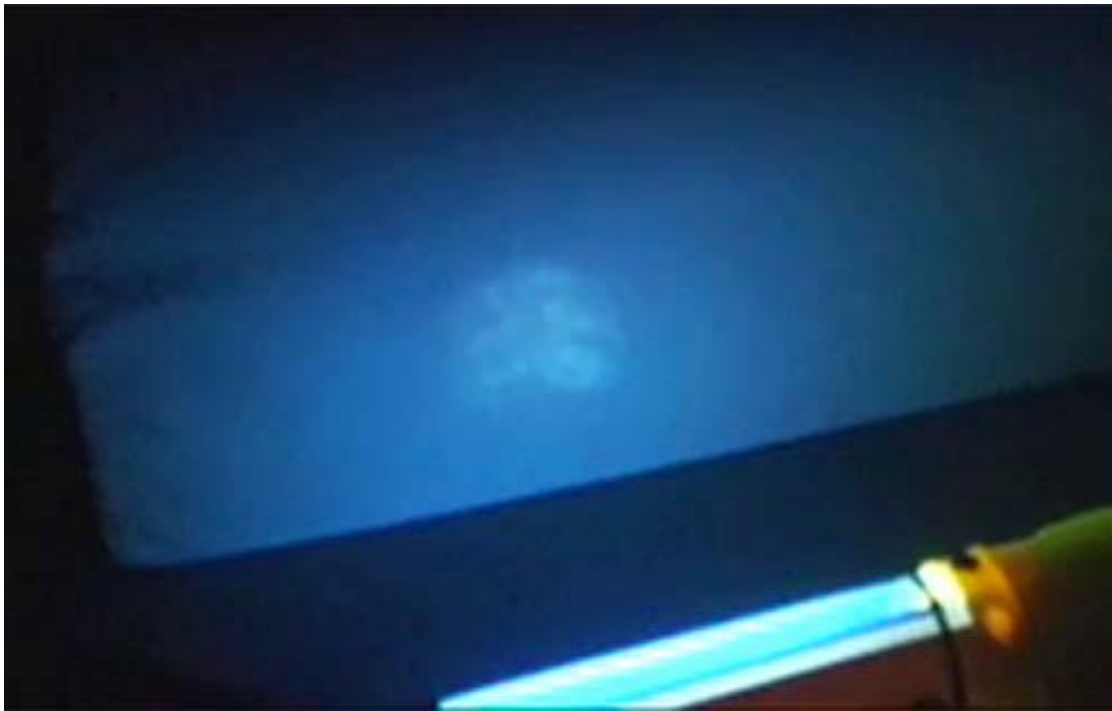
Black (ultraviolet) Light Detection of Body Fluid Contamination that may Indicate Fraying

It is also important that all pads be periodically tested using a black light to detect biologic contamination. A black light provides light in the ultraviolet wavelengths that is especially sensitive in detecting biological material such as blood, fingerprints, body fluids, etc. Biological material remaining on the pads will light up under black light exposure. This is an excellent way to confirm that the cleaning procedures are adequate. If biological material remains after proper cleaning it may indicate the covering material has been frayed or breached, thus allowing fluids to seep into the fabric itself and possibly penetrate to the underlying foam. Experiments performed by Ryan Whitney (a medical student who experimented with MRSA and MRI pads) (personal communication) have shown that MRSA could even go through frayed fabric covers without a tear and get into the central core where it is not possible to disinfect. This also demonstrates the necessity for pads and positioners to contain permanent antimicrobial agents in the covers and foam cores. More studies are needed to more thoroughly understand the depth of this problem and exactly how many pads in use today are contaminated.
