Preventing Infection in MRI

-Best Practices: Infection Control in and around MRI Suites-

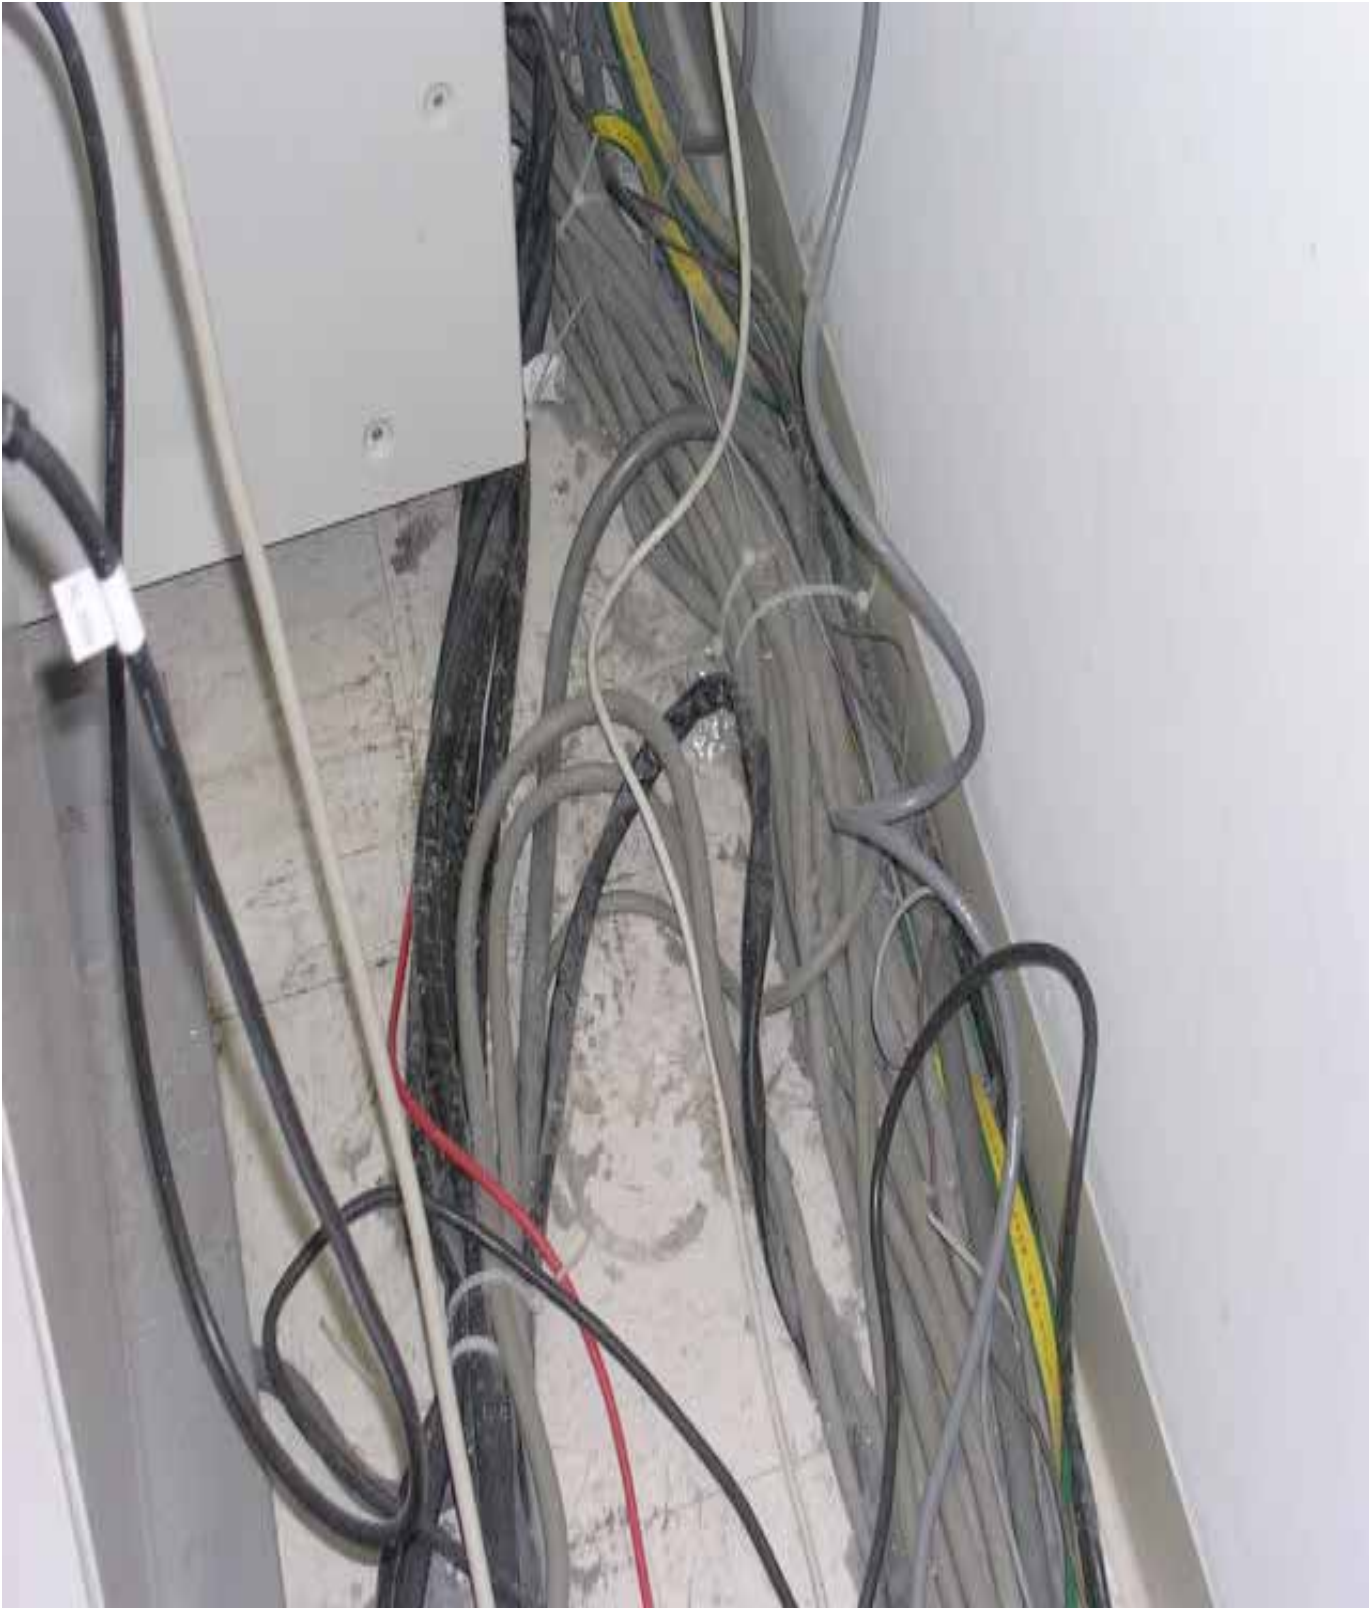
Cables in the MRI Room

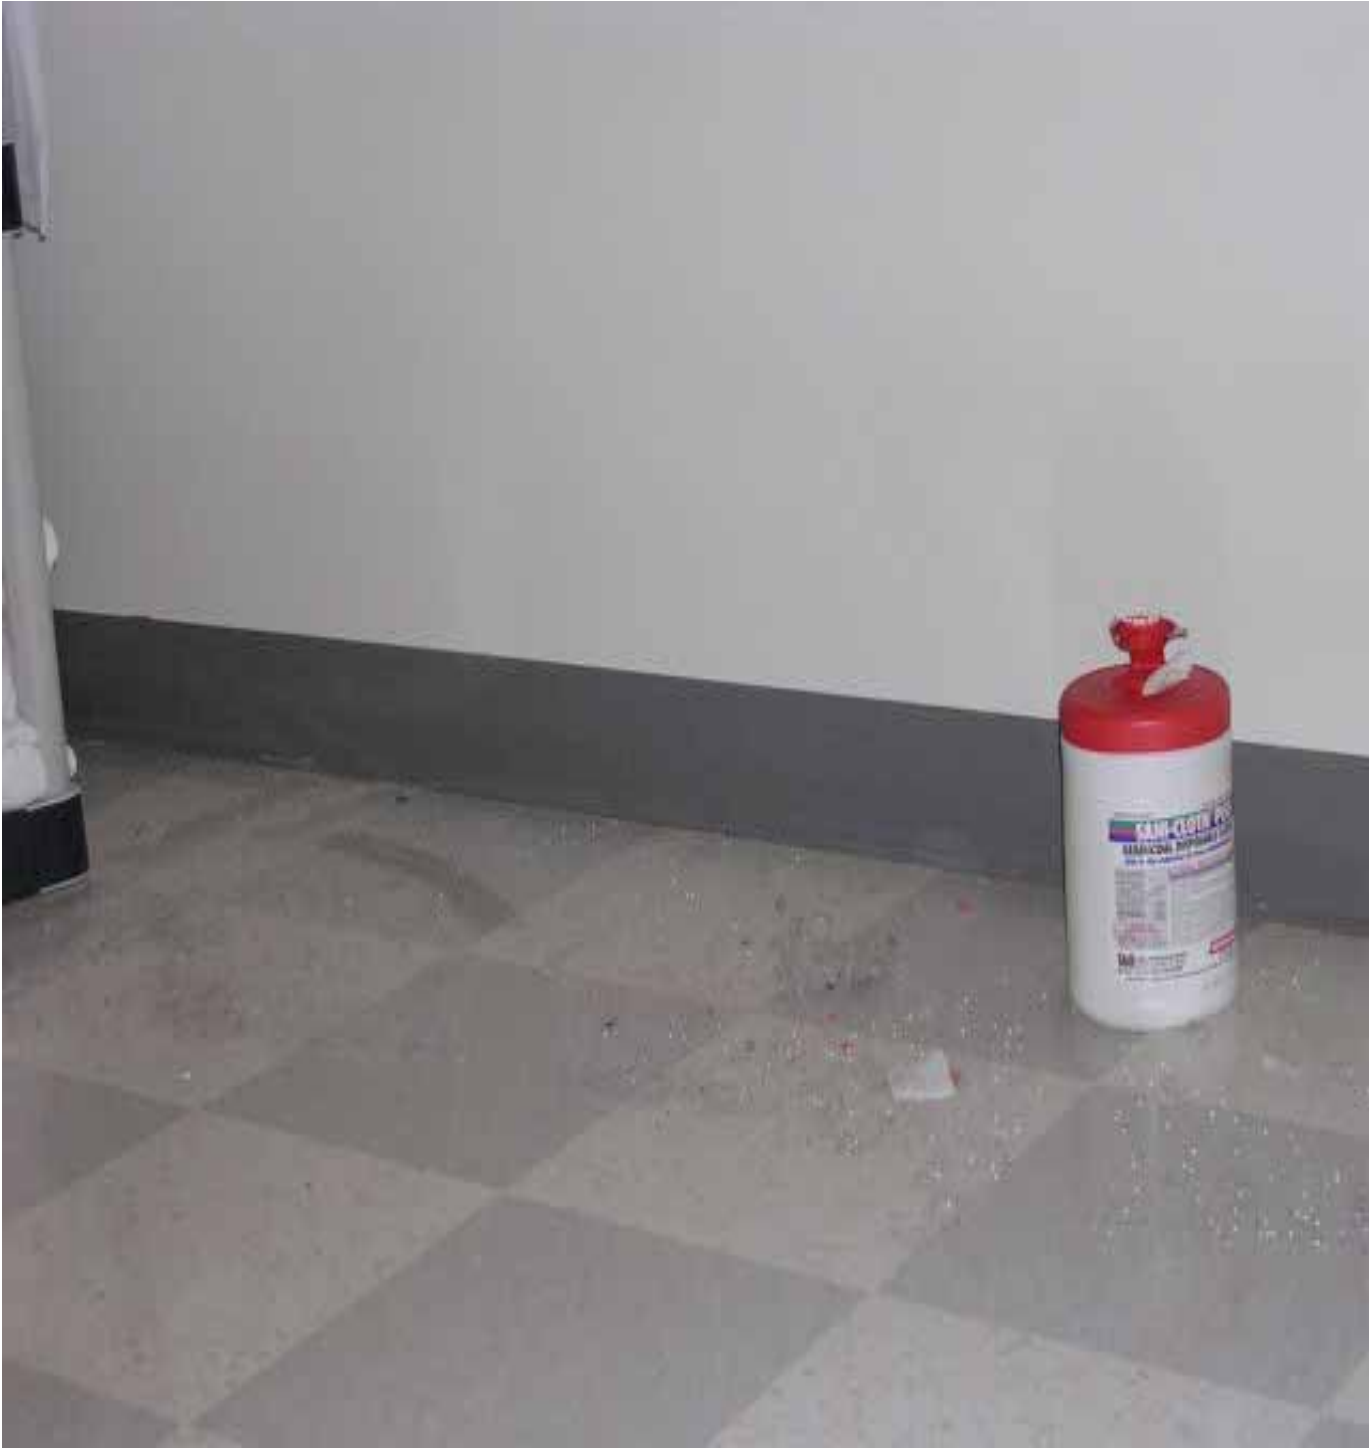
MRI Floor – Note that only the front half has been cleaned

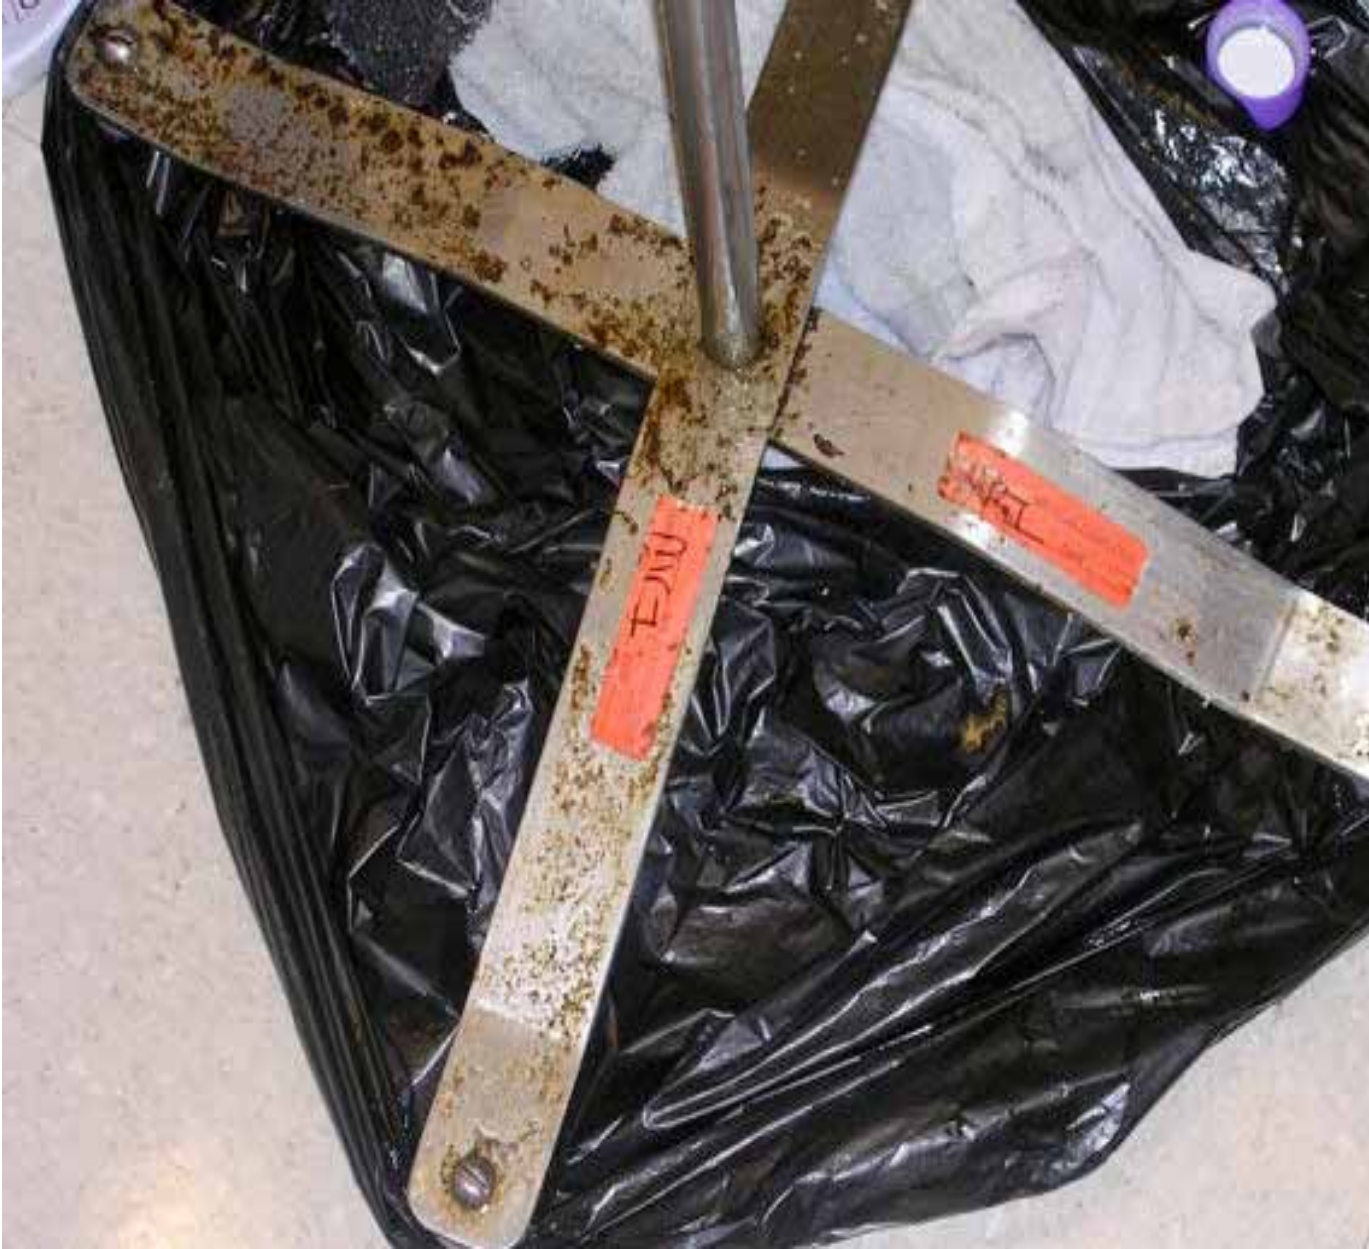
MRI-Compatible Aluminum IV Pole

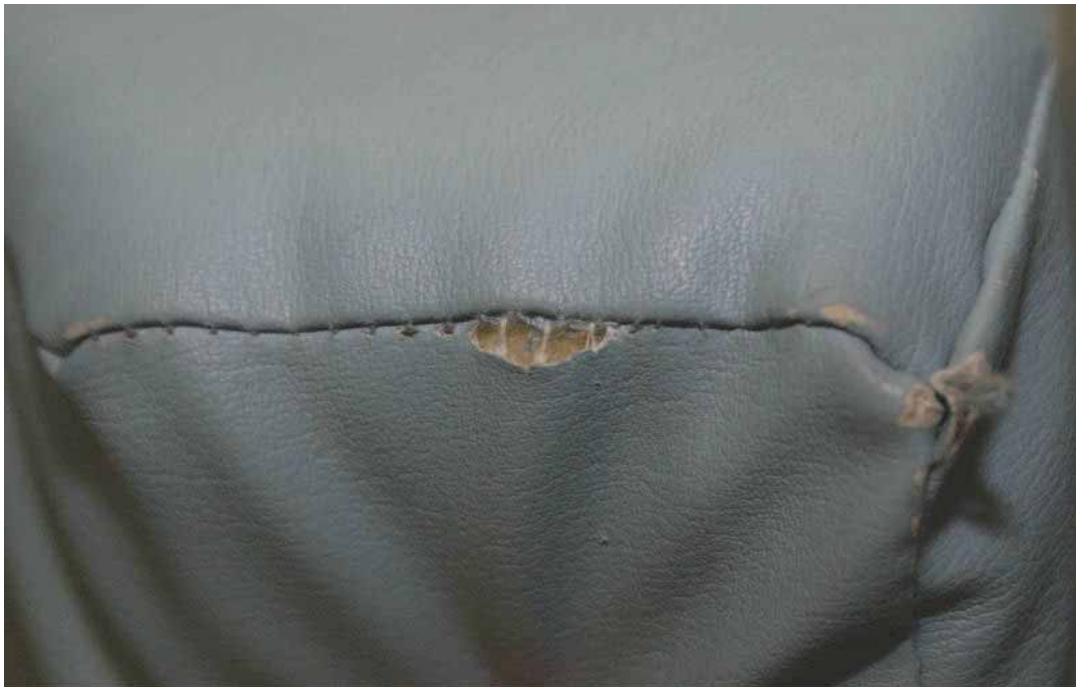
Torn and Frayed Table Pad

In the late 1980's and early 1990's when many of the pads systems in use today were developed, they were not designed to take the wear-and-tear of five to ten thousand patients a year for so many years. The fabric covers were coated with some type of plastic to make it water proof. However this plastic wears off especially with cleaning solutions as well as with use. As a result, pad coverings have worn out exposing the foam core or have lost their ability to prevent penetration of bacteria and fluids into the central core, where it is not possible to be cleaned.

This is clearly another reason why all pads must be inspected with a magnifying glass, and if any holes or loss of integrity of the covering material in any way is detected, the pads *must be replaced*.
